Perforation of Superior Vena Cava /Azygos Veins junction Leading to a Massive Hemothorax Requiring Thoracotomy Following Insertion of Tunneled a Haemodialysis Catheter; A Case Report

Citation: Awad Abdalla widaa, Nosiba Mohammed Hassan. Perforation of Superior Vena Cava /Azygos Veins junction Leading to a Massive Hemothorax Requiring Thoracotomy Following Insertion of Tunneled a Haemodialysis Catheter; A Case Report. American J Pathol Res. 2025; 4(1): 1-6.

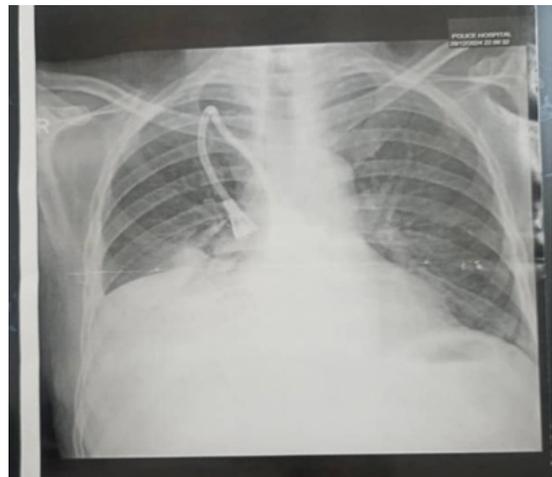
Figure 1: Whitening of mid and lower lobe of the right lung field and dialysis catheter in- situ.

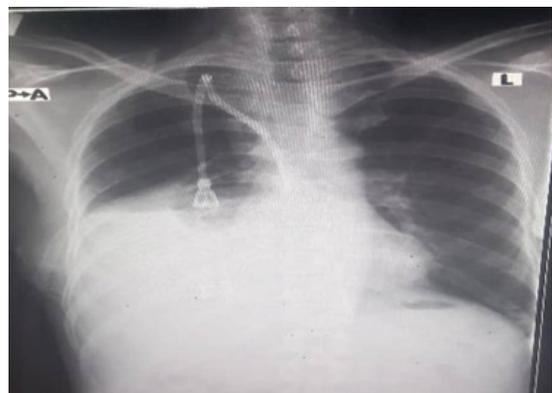
Figure 2: Antero posterior view CXR was done to evaluate the condition and showed regressed the haemothorax shadow and dialysis catheter in- situ.
