Sonography of Partial Tear of Distal Long Head of Biceps Tendon

A 64-year-old female presents herself to the ED. Her chief complaint is left arm pain x 4 days, with hx of past injury. Ultrasound imaging confirmed a partial tear in the long head biceps tendon at the myotendinous junction.

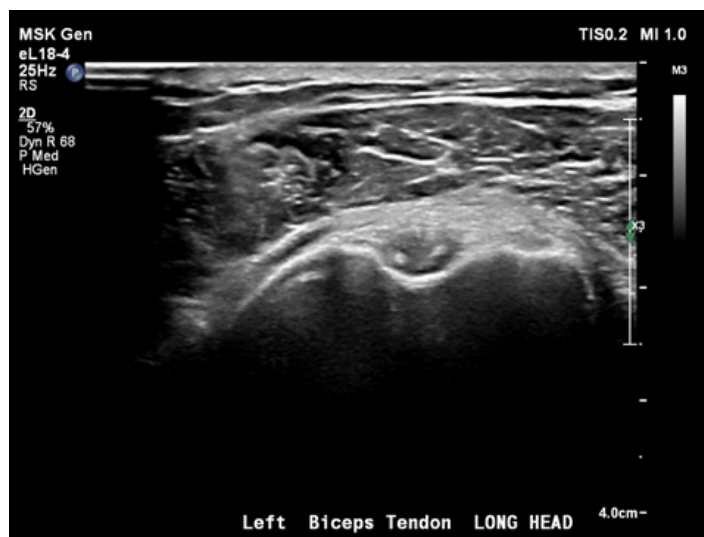
Figure 1: Sonographic image in the transverse plane of the long head bicep tendon in the bicipital groove.

The transverse view of the bicep tendon is shown Figure 1. The long head of bicep tendon is in the bicipital groove, which confirms there is no subluxation and the origin of the long head is intact. The long view of the bicep tendon is shown in Figure 2, which shows the parallel internal fibrillar structure. There is effusion represented by dark hypoechoic area under the tendon. Subscapularis tendon is intact and show normal echo pattern Figure 3. Scanning further distal to the bicipital groove focal defect can be seen at the myotendinous junction, as shown in Figure 4. Further distal, a clear partial tear is seen with a clear hypoechoic line perpendicular to the long axis shown in Figure 5.

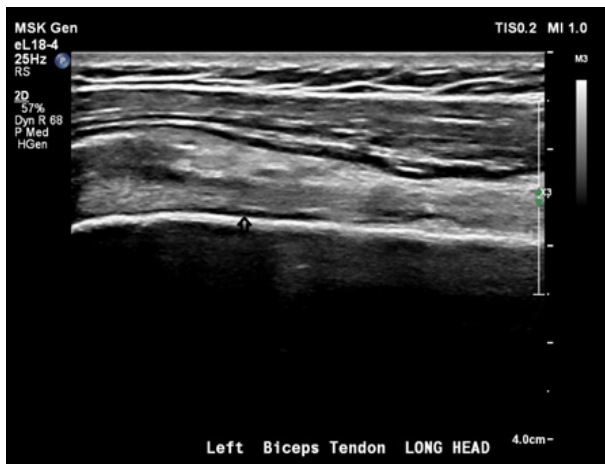
Figure 2: Sagittal view of the bicep tendon at the bicipital groove. Notice the fibrillar pattern and hypoechoic line under the tendon indicating effusion.

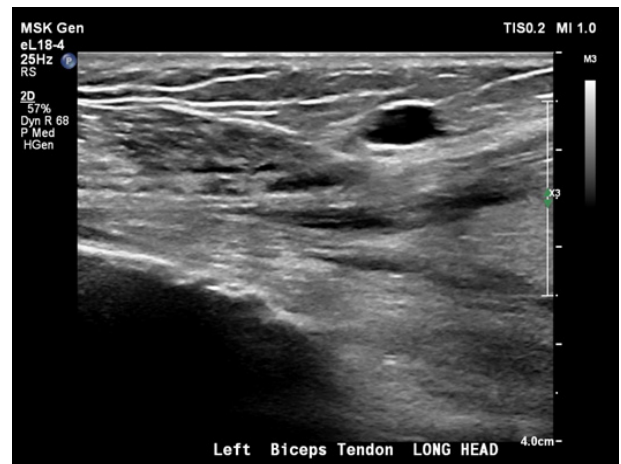
Figure 4: Focal defect and fluid at the myotendinous junction.

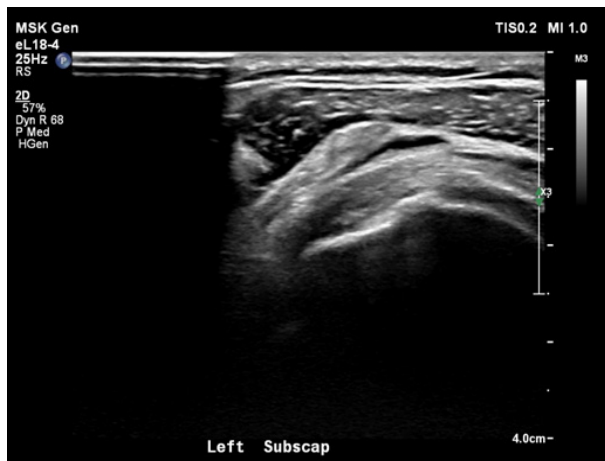
Figure 3: Transverse view of the subscapularis tendon showing normal echotexture.

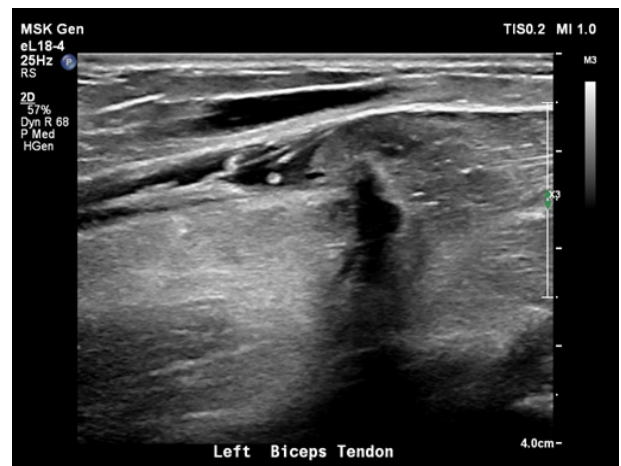
Figure 5: Focal defect showing hypoechoic line perpendicular to the long axis indicative of partial tear.

In summary, the ultrasound exam shows a partial tear of the long head bicep tendon below the bicipital groove at the myotendinous junction.
